## Rivian Puck Modification QRG

### Purpose and Overview

This document provides instructions on how to modify the existing Rivian Lifting Pucks as currently the alignment pins are becoming crushed/deformed during normal operations. The crushed alignment pin makes the puck improperly mate with the lift point surface which negatively impacts the safety of Our People and increases the risk of vehicle damage.

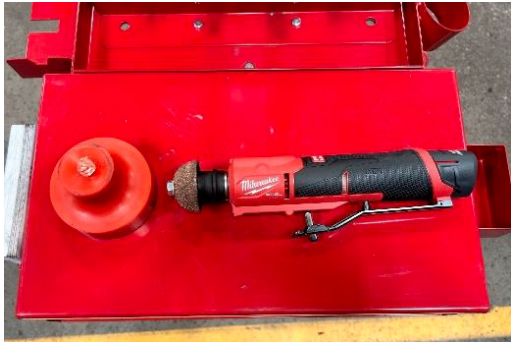
| Step | Action |
|---|---|
| 1 | <p>Collect the tools and equipment needed:</p> <ul style="list-style-type: none"> <li>Gloves</li> <li>Face shield</li> <li>Rivian puck</li> <li>Low-speed tire repair buffer with rasp</li> <li>Rivian puck <ul style="list-style-type: none"> <li><b>Note:</b> Ensure the tire repair buffer is on the buff setting before use</li> </ul> </li> </ul> <div> <p><b>Critical To Safety</b></p> </div> <p>Gloves and face shield must be worn when performing the modification.</p> |

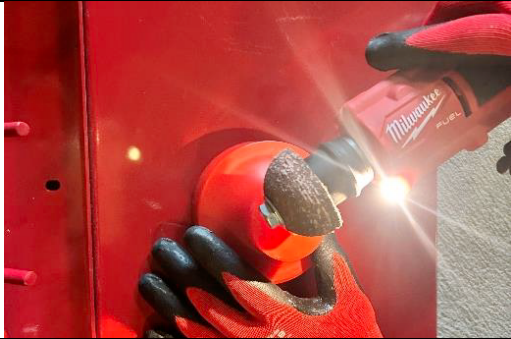
| Step | Action |
|---|---|
| 2 | <p>Place the Rivian puck on a flat surface and begin to grind down the alignment pin using the rasp.</p> <p><b>Note:</b> Ensure the hand holding the puck is not in the path of the rasp to reduce the chance of injury</p> |

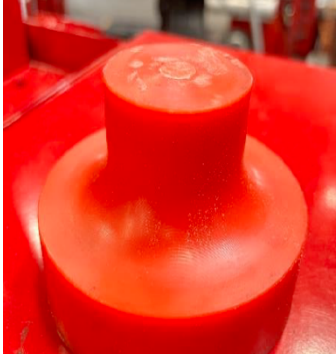
| Step | Action |
|---|---|
| 3 | <p>Grind the alignment pin until it is flush with the top surface of the puck.</p> <p><b>Note:</b> With the removal of the alignment pin, it is even more important that the puck is centered on the lift point to avoid potential damage.</p> |
