## Saylor-Beall Compressor Inspection

March 30, 2021

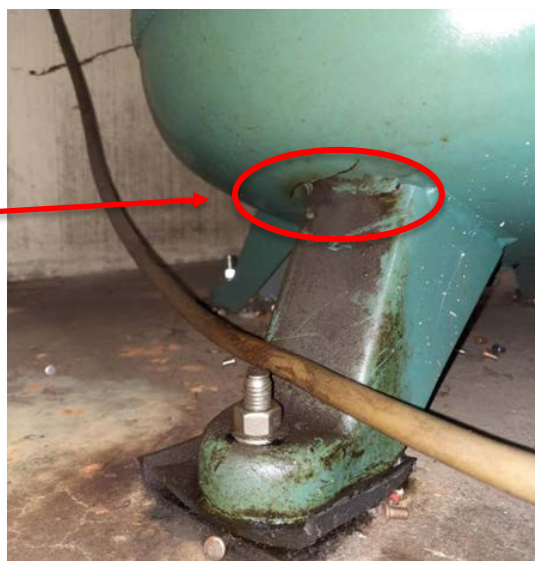
☐ Using bubble check, spray the entire welded area where the compressor foot meets the tank. Be sure to spray all sides of each of the legs.

1. If a crack and/or leak is detected, complete steps **a** and **b** listed below:
  - a. Shut down the compressor
  - b. Lock out/tag out the compressor
2. Complete the survey sent to you in the "Final Step" even if you did not identify a crack or leak.

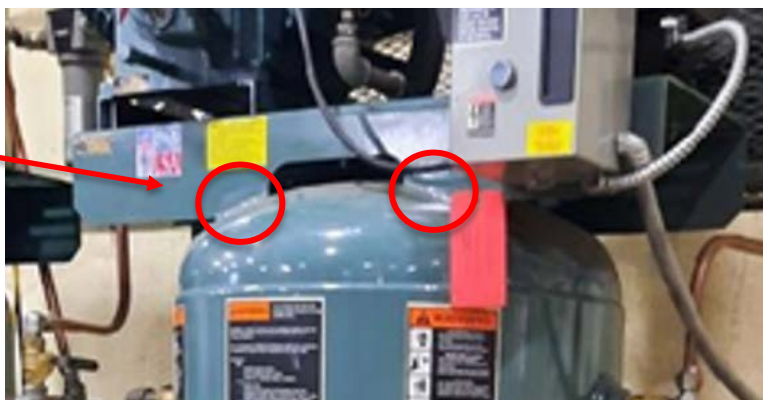
☐ Using bubble check, spray the welded areas where the motor attaches to the tank.
